Manhole Inspection Summary

Manhole # S43I__054MH

Insp Date: **4/30/08 9:02 AM**

Location Address: **305 s bethel st**

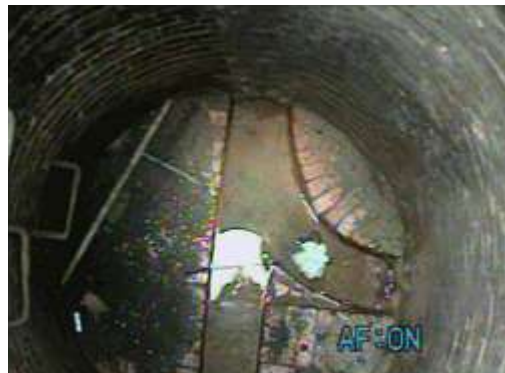
Top View

Comments **the third pipe in the top view is abandoned**

connection @ 3 oclock abandoned

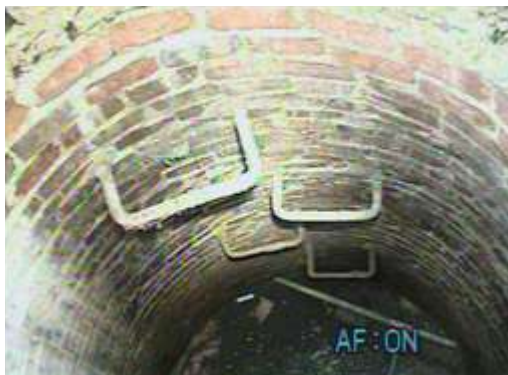
Defect 2

Steps Count: **4** Missing: **0** ☒ **Corroded**

corroded stairs

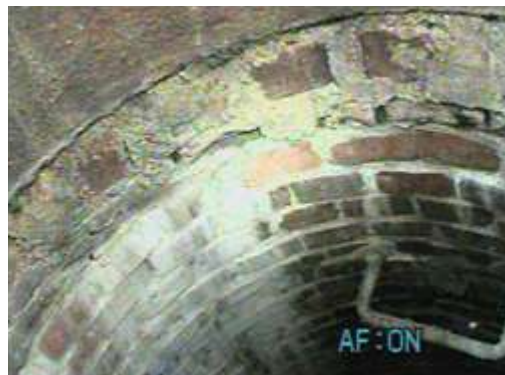
Defect 1

Condition: ☐ Sound ☒ **Cracked** ☐ Root Intrusion ☒ **Loose Brick** ☐ Deteriorated

cracked chimney loose bricks frame adjustment

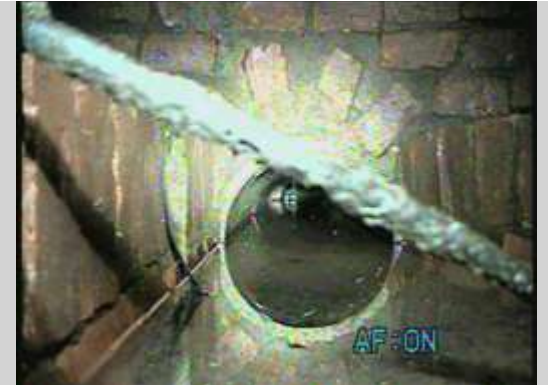
12 O'Clock Outflow

8 in. Circular Gravity Sewer
Pipe Out @ 12 O'Clock

Invert Depth: **8.33** (ft.) Flow Characteristics: **Slow**

Infiltration: **None** Pipe Seal Cond: **Unknown**

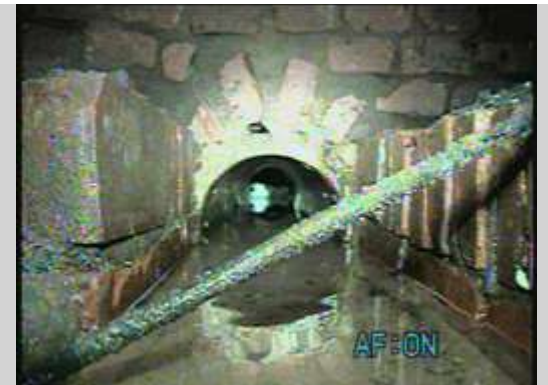
6 O'Clock Inflow

8 in. Circular Gravity Sewer
Pipe In @ 6 O'Clock

Invert Depth: **8.30** (ft.) Flow Characteristics: **Slow**

Infiltration: **None** Pipe Seal Cond: **Unknown**
